DECLARATION OF NICHOLAS J. DURISEK, PH.D., P.E.

EXHIBIT B

REY (NICOLAS)
V.
GENERAL MOTORS

August 31, 2020

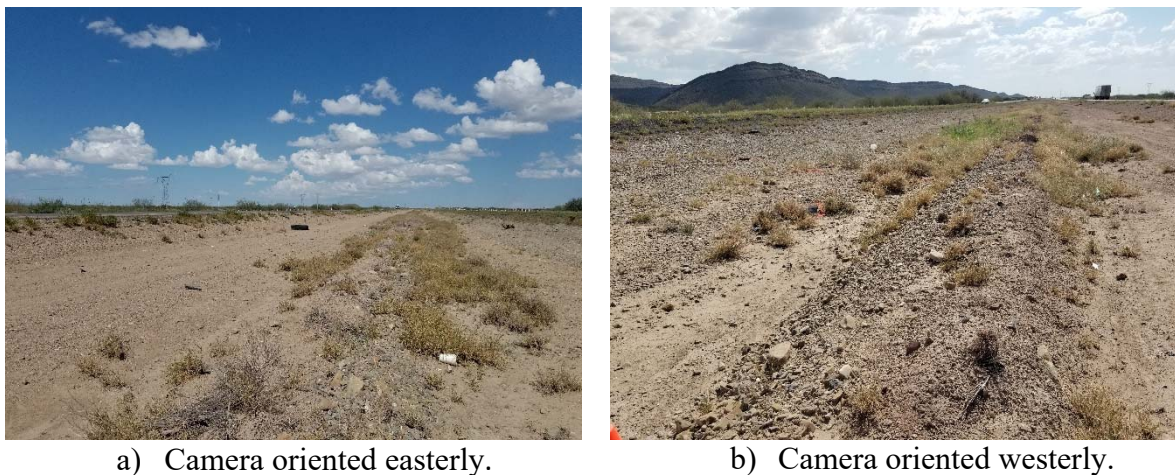
Figure 4. Berm in center median.

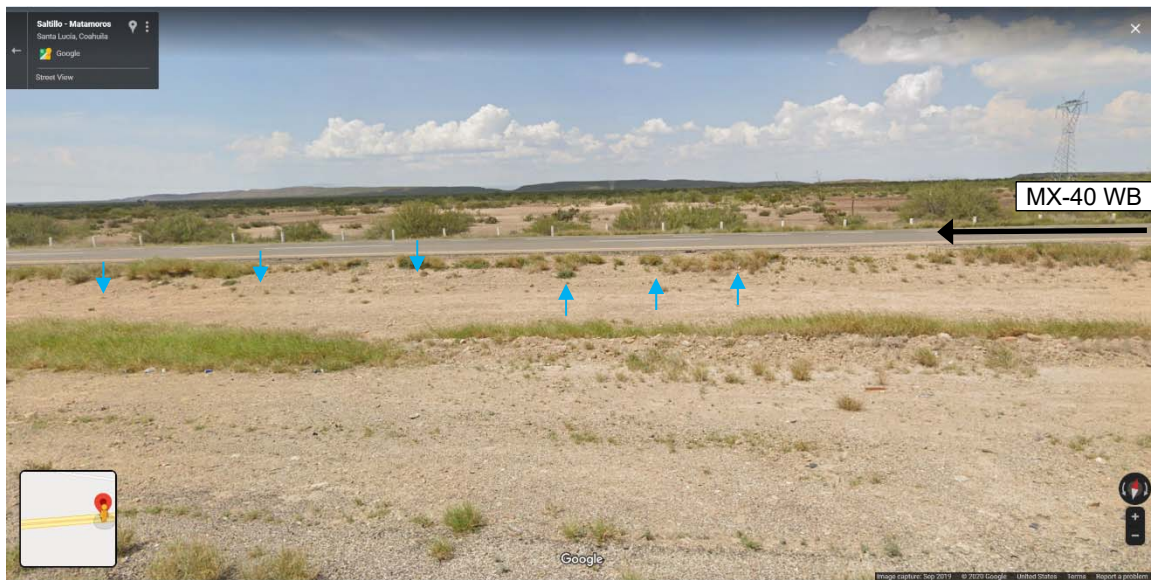
Google Street View photographs were taken at the scene in September 2019, within the month after the crash. In the area of the police measured roadway exit, tire marks were visible entering the center median at a gradual angle, shown in Figure 7. The travel lanes in the area of roadway exit were absent of tire marks, Figure 8, consistent with the police documentation. The raised berm in the center median and far side (eastbound) uphill median slope had contact interruptions consistent with the median tire mark trajectory, shown in Figure 9. The measurements recorded by the police were found to be relatively consistent with measurements taken during my scene inspection. I did not identify any environmental conditions at the scene that would have caused the loss of control or that would have prevented Mr. Rey from slowing his vehicle and driving onto the shoulder to stop.

Figure 7. Tire marks gradually departed roadway at police measured roadway departure, Google Street View, September 2019.

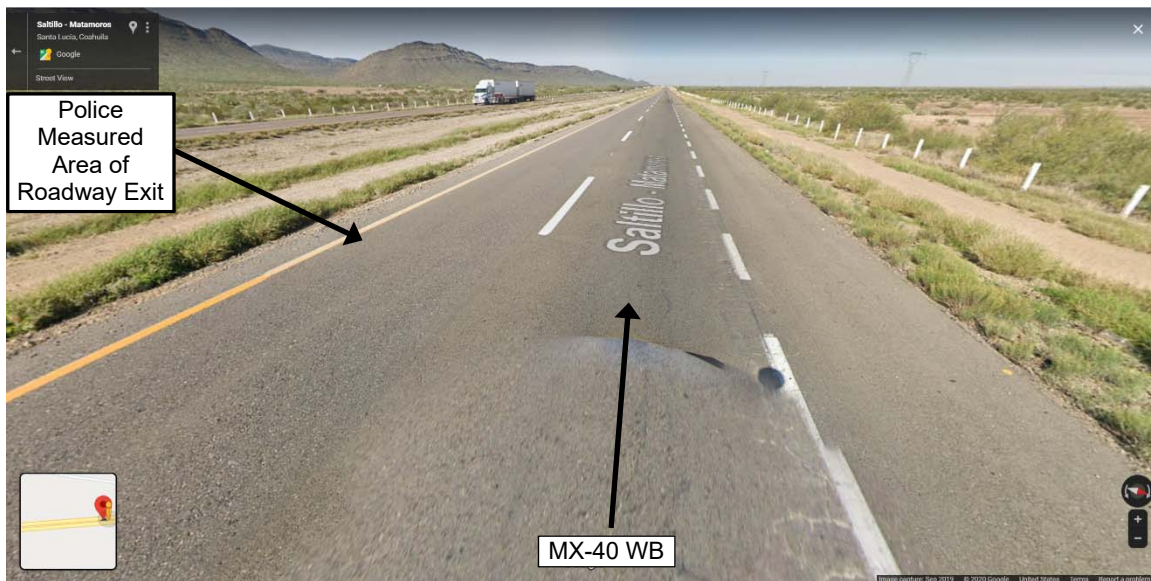
Figure 8. No tire marks on the roadway on westbound MX-40 near the police documented area of roadway exit, Google Street View, September 2019.

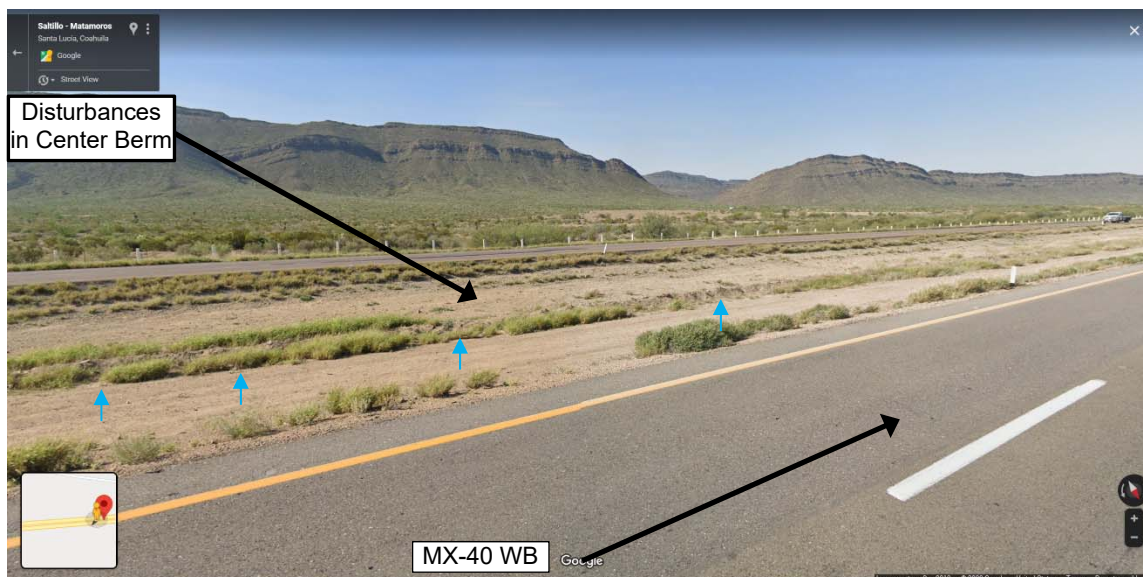
Figure 9. Disturbances in center berm and uphill median slope, Google Street View, September 2019.

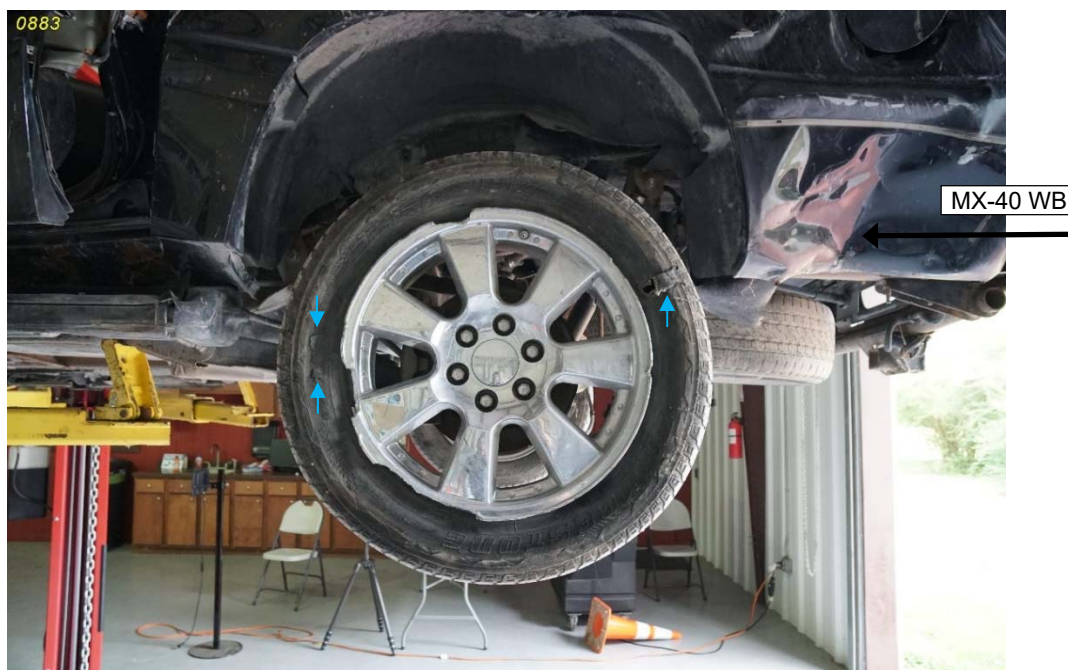
The subject vehicle was inspected on June 19, 2020 and July 14, 2020; its condition was documented with notes, photographs, and electronic measurements. Figure 10 is a graphic representation of the GMC Yukon XL electronic measurements. The vehicle was a black 2006 GMC Yukon XL Denali four-wheel-drive having VIN 1GKFK66U06J133348. It was equipped with a 6.0 liter V-8 engine, automatic transmission, front-impact airbags, and a four-channel antilock brake system (ABS). The tires mounted on the vehicle at the time of the crash were Bridgestone Dueler H/L Alenza P275/55R20 tires, they were manufactured during the fifth week of 2016, and each had adequate tread depth. All four tires were deflated. The wheels were original equipment and were constructed of aluminum. The left side wheels were fractured at the wheel flange in multiple locations, abraded on the wheel flange and wheel face, and bent in multiple locations. Dirt was adhered to the left-front wheel. The left-front tire inner sidewall was torn or cut. The left-rear tire was punctured and cut on the outer sidewall in multiple locations, shown in Figure 11. I inspected the tires and wheel openings, including the left-rear location, for evidence of a tire disablement and found none. The condition of the tires and wheels were consistent with rollover crash damage.

Figure 11. Left-rear wheel fractured, abraded, and bent; left-rear tire punctured or cut in multiple locations (indicated).

I have reviewed Dr. Ziejewski's reports dated February 5, 2020, April 20, 2020, and August 3, 2020. I disagree with Dr. Ziejewski's conclusion that the cause of the crash was a rear tire puncture. No evidence on the vehicle or at the scene support a rear tire puncture prior to Mr. Rey driving off the roadway and into the center berm. The physical evidence on the vehicle and the characteristics of the scene are consistent with the tire and wheel damage being from impacts during the overturn. Dr. Ziejewski used a police measurement from rest to an area where the vehicle was being overturned for the overall roll distance; this distance is an underestimate for the start of the overturn and is not consistent with the number of scratch patterns present on the vehicle nor the location of the physical evidence at the scene. Fractured driver-door window glass was found at the scene upstream of Dr. Ziejewski's location for the start of the overturn. Dr. Ziejewski's roll distance measurement was within the field of vehicle parts located in the center median, not at four-wheel lift. His underestimate of roll distance resulted in an underestimate of his calculated speed at four-wheel lift and his number of rolls. Dr. Ziejewski correctly indicated the roll direction from the physical evidence on the vehicle in Figures 11 through 13 of his reports, but incorrectly concluded that the directional evidence indicated a driver side leading overturn; Mr. Rey overturned his vehicle passenger side leading. Dr. Ziejewski incorrectly concluded that the CDR record was not related to Mr. Rey's crash. I found the data retrieved to be consistent with Mr. Rey's crash.

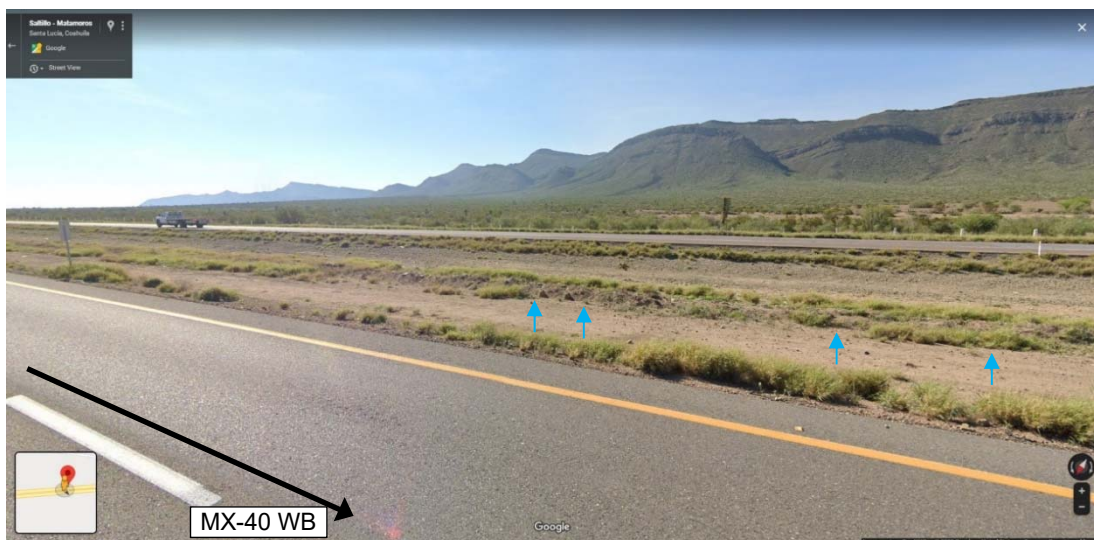
The lower structures of the GMC Yukon XL engaged the median berm and far-side median slope. The recorded non-deployment event was likely Mr. Rey's first interaction with the berm and far-side median slope. During this interaction, the left-front lower cross member was likely abraded. After more than 600 feet of travel in the median soil and after an unknown number steering maneuvers, the vehicle was directed toward the median berm; the left side tires ramped up the median berm as the right side tires generated increased lateral forces, increasing roll motion passenger side downward while the vehicle was being yawed counterclockwise. The vehicle was overturned with its passenger's side leading. At four-wheel lift, the vehicle was likely being driven approximately 50 to 62 miles per hour. Disturbances in the soil in the likely area of four-wheel lift are shown in Figure 13. The vehicle likely underwent four and three-quarters revolutions with its passenger side leading over a distance of greater than 210 feet. The likely average roll rate during the overturn was approximately 320 degrees per second. The highest average roll rate between roll positions during the overturn was approximately 550 degrees per second, shown in Figure 14. According to testimony, the vehicle came to rest on its driver's side in the MX-40 median facing southeast. During the overturn, the driver and passenger roof rails interacted with the median berm during two different rolls, shown in Figure 15. Primary impacts to the forward and upper driver-door window frame likely occurred between one-half and three-quarters revolutions, one and one-half and one and three-quarters revolutions, and two and one-half and two and three-quarters revolutions. The driver-door window glass was likely broken between one and one-half and one and three-quarters revolutions, within the rollover area indicated by the police, but upstream of their measurement. The crash sequence from the start of the police documented roadway exit to rest is shown in Figure 16. The crash sequence from four-wheel lift to rest is shown in Figure 17. No physical evidence was present in the westbound travel lanes or shoulder indicating a steering or braking maneuver prior to roadway exit.

Figure 13. Disturbances in median berm near four-wheel lift, Google Street View, September 2019.

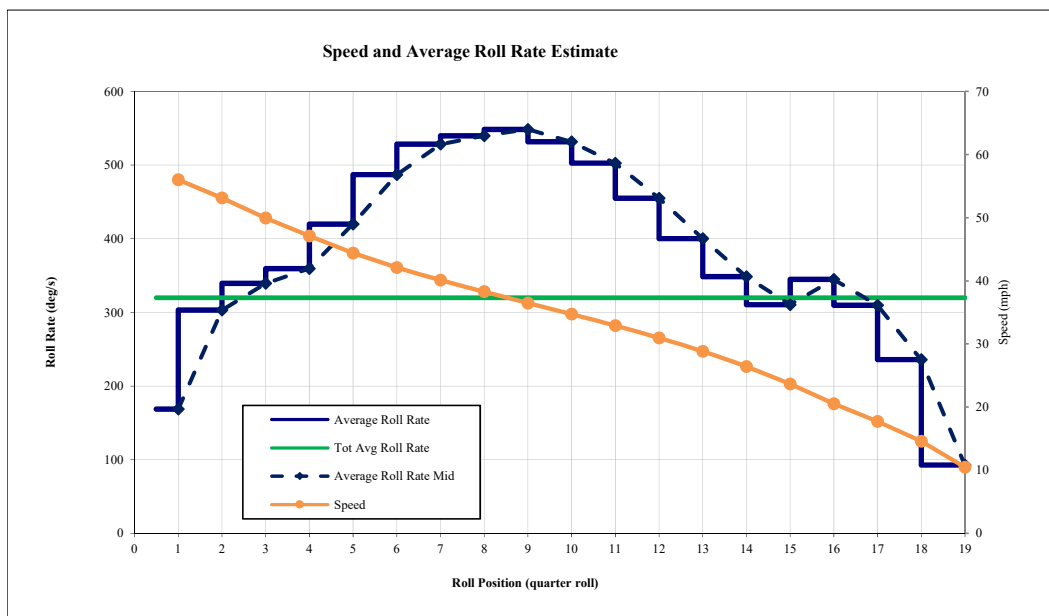
Using the physical evidence gathered from the vehicle and scene inspections, vehicle and scene photographs, police information, accepted engineering principals and techniques, and all information I have reviewed for this crash, I have determined the vehicle's most likely motion during the crash. Mr. Nicolas Rey was driving a black 2006 GMC Yukon XL Denali westbound in the left lane of MX-40. According to testimony, he had been a passenger and driver in the vehicle during an overnight journey through Mexico, to the United States Border, and then back towards Torreón. On the portion of the journey leading up to the crash, Mr. Rey began driving at approximately 6:00 a.m. until the time of the crash which was reportedly 10:30 a.m. Mr. Rey was driving in excess of 90 miles per hour (145 kilometers per hour) when he drove out of the westbound travel lane, across the narrow inner shoulder, and into the center median soil and grass at a gradual departure angle; the speed limit was 100 kilometers per hour (62 miles per hour). No physical evidence, including tire marks, indicated that Mr. Rey braked his vehicle or steered back towards his travel lane at the time of roadway exit. No physical evidence at the scene indicated that a tire on the vehicle became disabled. The vehicle was slowed as it interacted with the road edge and terrain as it traveled toward a berm in the center median. The trajectory of the tire marks visible in the Google Street View images taken soon after the crash to the consistent disruptions in the median soil were 260 to 350 feet from the police indicated roadway exit. This distance would have taken 2 to 3 seconds of travel time given Mr. Rey's speed, in-line with the CDR pre-crash data.

Figure 14. Speed and average roll rate analysis.

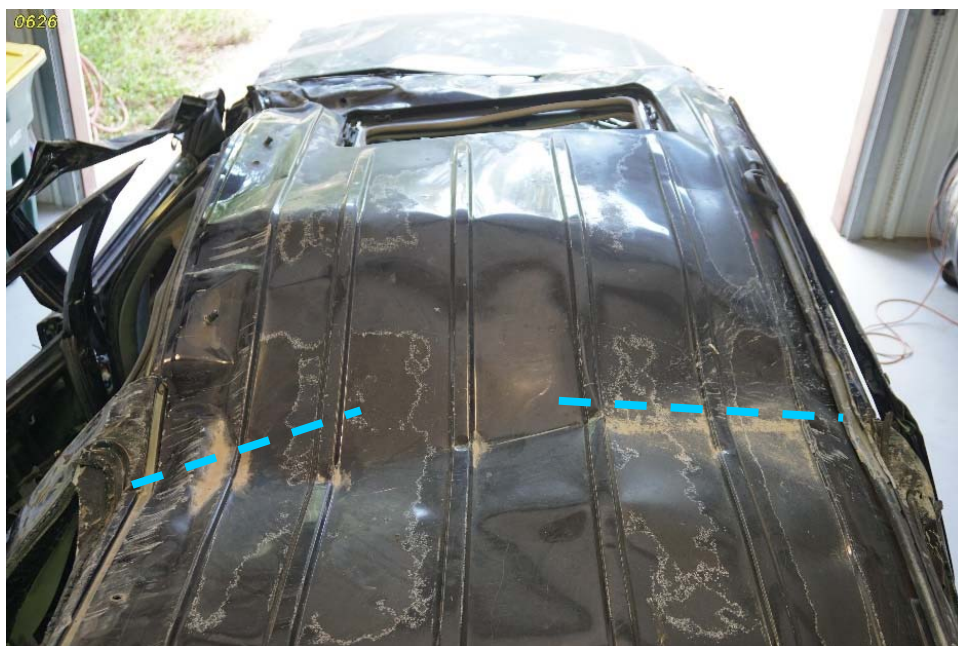
Figure 15. Roof contact with berm; abrasions in deformation at different angles.
